PHOTOGRAPHIC SURVEY OF THE LDEF MISSION

NASA Special Publication 531

Robert L. O'Neal

Langley Research Center
Hampton, Virginia 23681-0001

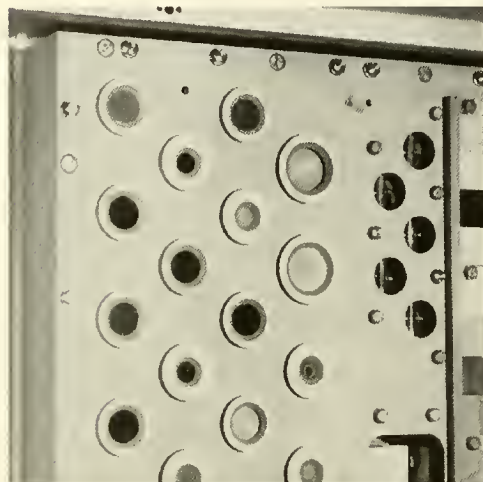
Figure 188 (Postflight). This photograph is of the upper left one-fourth of the module for experiment AO056. The experiment is intact, but has sustained some physical damage. The experiment sample located in the second circular holder from the top in the right row appears to be missing. A brown discoloration is present on the surface of the unpainted aluminum mounting plate. The discoloration is darker near the fasteners around the mounting plate edges and the filter and coating holders.

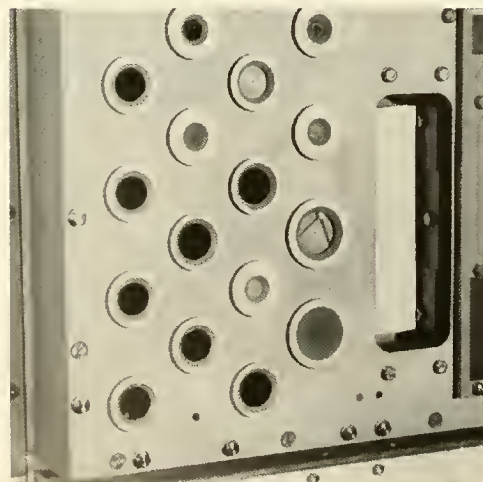
Figure 189 (Postflight). This photograph is of the lower left one-fourth of the module for experiment AO056. The experiment has sustained some physical damage. An impact crater and two cracks extending outward from the crater are visible in the experiment sample mounted in the second circular holder from the bottom in the right row of filter and coating samples. A brown discoloration is present on the surface of the unpainted aluminum mounting plate and near the filter and coating holders.

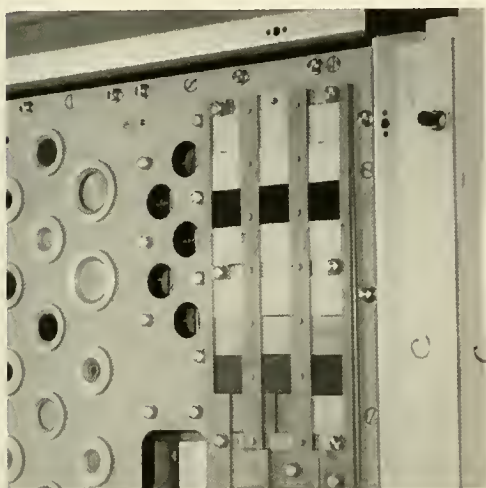
Figure 190 (Postflight). This photograph is of the upper right one-fourth of the module for experiment AO056. The experiment is intact, but brown discolorations appear on surfaces of the Materials Technology Experiment samples that are mounted in the right half of the module.

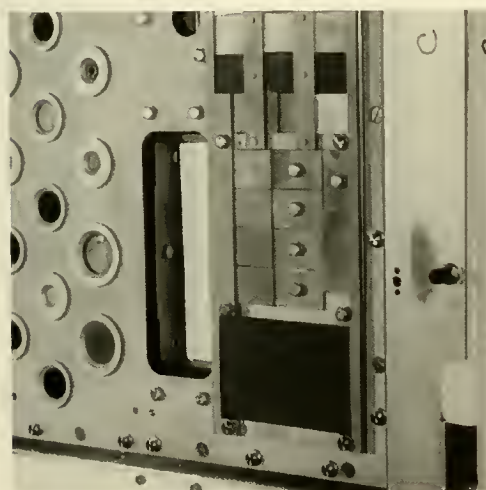
Figure 191 (Postflight). This photograph is of the lower right one-fourth of the module for experiment AO056. The experiment is intact, but brown discolorations appear on surfaces of the Materials Technology Experiment samples that are mounted in the right half of the module.

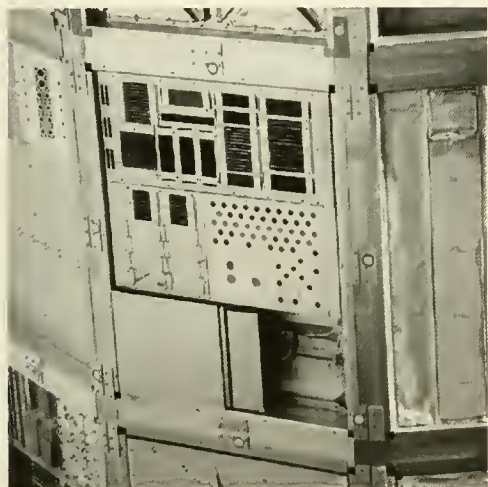
Figure 193
Photo No.: S32-76-001
Dup. Neg. No.: L90-10374
LISAR No.: EL-1994-00659
Photo Credit: JSC
Photo Date: 1/12/90
Location: In Flight
Subject: In-Flight Survey of Tray B9

Figure 193 (In Flight). In this photograph, the top and lower flanges have abrasions from prelaunch testing. Experiment AO147 component, located on the upper one-third of the tray mounting plate, is intact and the mounting hardware appears secure. Much of the mounting hardware is discolored. In the left center, only a few fragments of the 14 polymeric and resin thin-film materials have survived the mission.

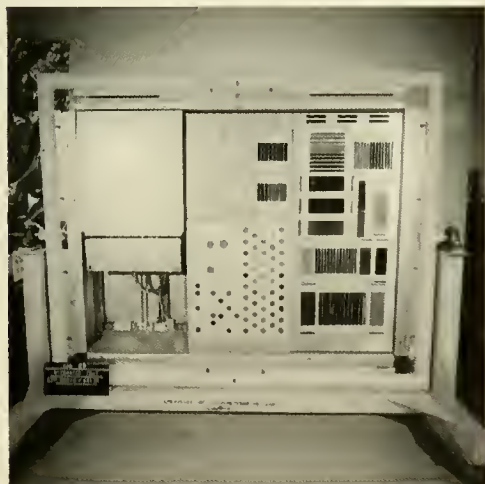
Figure 194
Photo No.: KSC-390C-1913.09
Dup. Neg. No.: L91-2536
LISAR No.: EL-1994-00281
Photo Credit: KSC
Photo Date: 3/13/90
Location: KSC SAEF II
Subject: Postflight Survey of Tray B9

Figure 194 (Postflight). The right and left flanges and each end of the top flange of the tray have abrasions from prelaunch testing. Most test specimens are intact except in the upper left center one-third where many thin films are damaged or missing. Mounting hardware is discolored. The EECC located in the left section of the experiment tray has a dark brown discoloration on the mounting structure in the bottom of the tray.

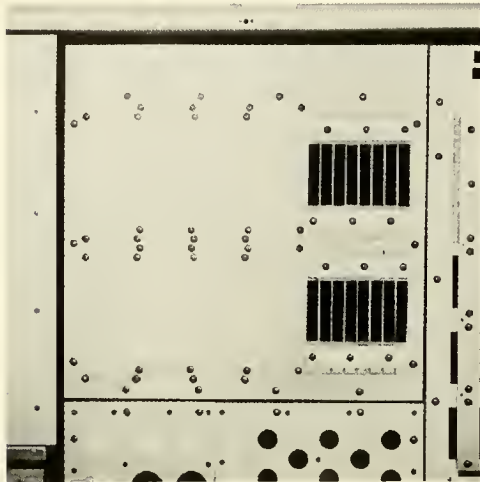
Figure 195
Photo No. KSC-390C-1913.11
Dup. Neg. No.: L91-2538
LISAR No.: EL-1994-00419
Photo Credit: KSC
Photo Date: 3/13/90
Location: KSC SAEF II
Subject: Postflight Detail of Upper Center of
Tray B9

Figure 195 (Postflight). This photograph of the upper center one-sixth of the tray shows that thin-film test specimens are missing. There is a brown discoloration at the upper left corner of the baseplate.

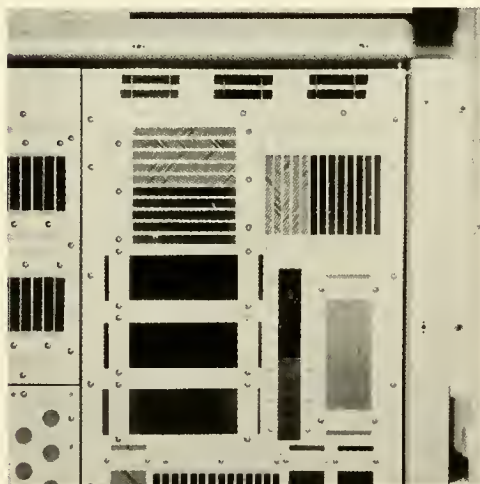
Figure 196
Photo No.: KSC-390C-1913.12
Dup. Neg. No.: L91-2539
LISAR No.: EL-1994-00420
Photo Credit: KSC
Photo Date: 3/13/90
Location: KSC SAEF II
Subject: Postflight Detail of Upper Right of Tray B9

Figure 196 (Postflight). This photograph of the upper right one-sixth of the tray shows that the test specimens are intact. However, some specimens are somewhat discolored and some have diagonal markings and patterns.

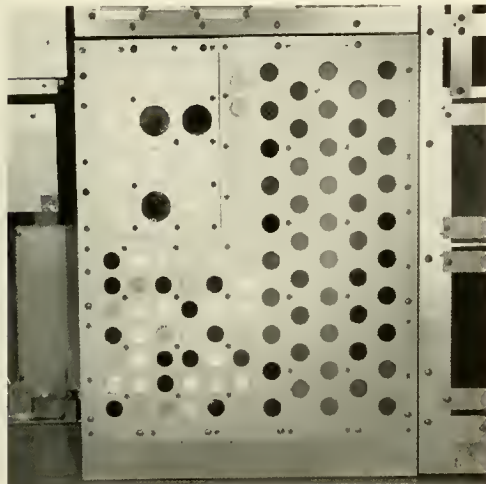
Figure 197
Photo No.: KSC-390C-1914.03
Dup. Neg. No.: L91-8108
LISAR No.: EL-1994-00421
Photo Credit: KSC
Photo Date: 3/13/90
Location: KSC SAEF II
Subject: Postflight Detail of Lower Center of
Tray B9

Figure 197 (Postflight). This photograph of the lower center one-sixth of the tray shows that some test specimens have changed color and some appear damaged.

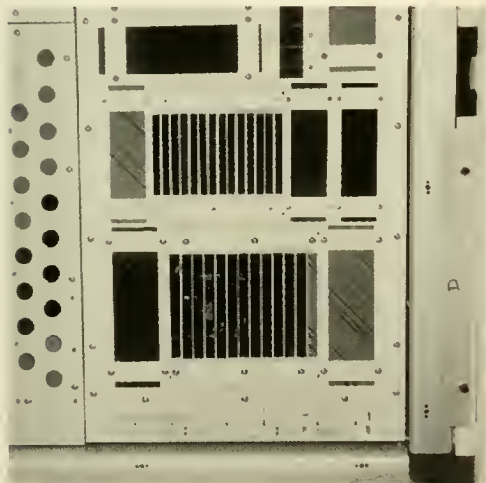
Figure 198
Photo No.: KSC-390C-1914.04
Dup. Neg. No.: L91-8109
LISAR No.: EL-1994-00422
Photo Credit: KSC
Photo Date: 3/13/90
Location: KSC SAEF II
Subject: Postflight Detail of Lower Right of Tray B9

Figure 198 (Postflight). This photograph of the lower right one-sixth of the tray shows that the test specimens are intact, but some are discolored and some have diagonal markings and patterns.

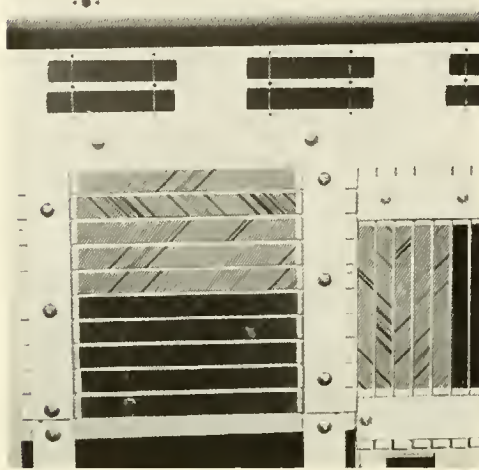
Figure 199 (Postflight). This close-up photograph shows the general discoloration of a group of test specimens in the upper right of the tray.

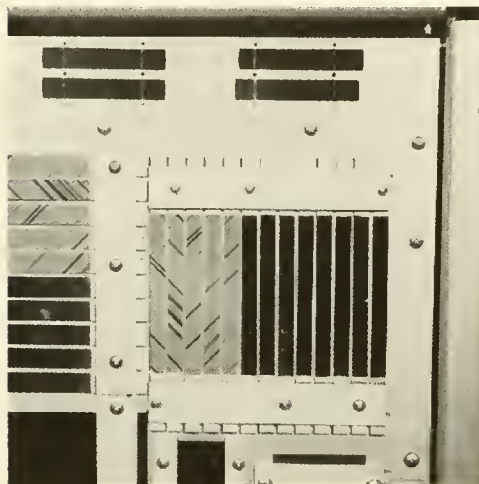
Figure 200 (Postflight). This close-up photograph shows the general discoloration of a group of test specimens in the upper right of the tray.

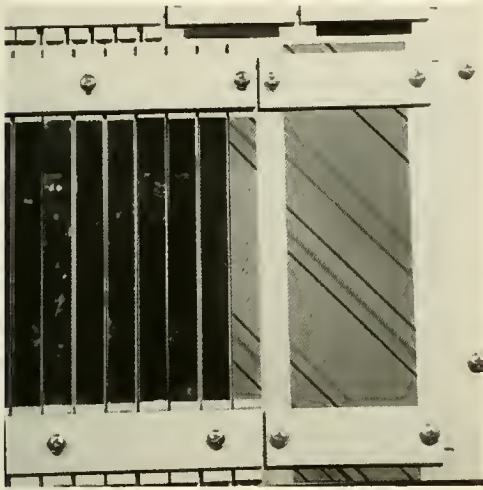
Figure 201
Photo No.: KSC-390C-1916.02
Dup. Neg. No.: L91-8083
LISAR No.: EL-1994-00425
Photo Credit: KSC
Photo Date: 3/13/90
Location: KSC SAEF II
Subject: Postflight Detail of Lower Right of B9

Figure 201 (Postflight). This close-up photograph shows the general discoloration of a group of test specimens in the lower right of the tray.

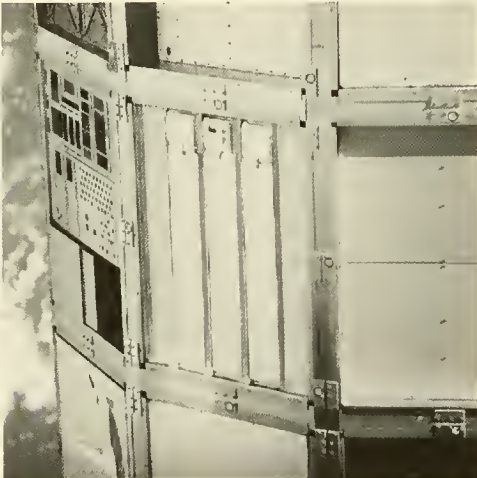
Figure 202 (In Flight). The experiment consisted of three transverse flat-plate heat pipe modules, a power system for the heaters, a data acquisition and storage system, and an aluminum support structure. The surface of the experiment that was exposed to the space environment consisted of the exterior surfaces of the three heat pipe modules and silvered Teflon film. Thermal blankets covered the aluminum mounting hardware and openings between the hardware and the tray sidewalls. The raised surface at the end of each heat pipe module contained the fluid reservoir. The specular surface of the silvered Teflon film has become diffuse and appears white with numerous impact craters; black specks are visible on the white surfaces. Some areas of pronounced discoloration are visible.

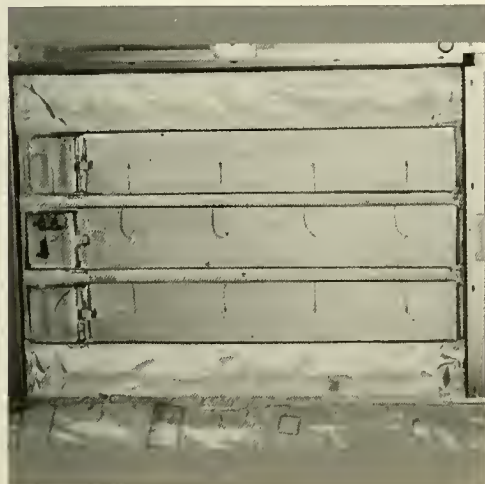
Figure 203 (Postflight). The thermal blanket with the patches across the lower edge of the photograph was part of the RMS thermal cover and was not associated with the experiment S1002. The specular surface of the silvered Teflon film has become diffuse and appears white. Numerous impact craters, black specks, and other discolorations are visible.

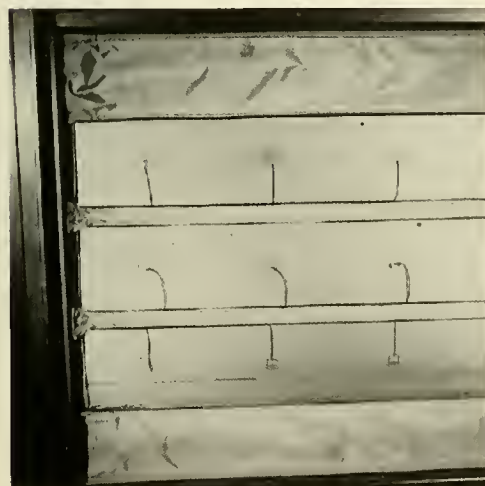
Figure 204 (Postflight). This photograph of the left of the tray shows that the silvered Teflon film now appears diffuse. Space debris impacts appear as small black dots.

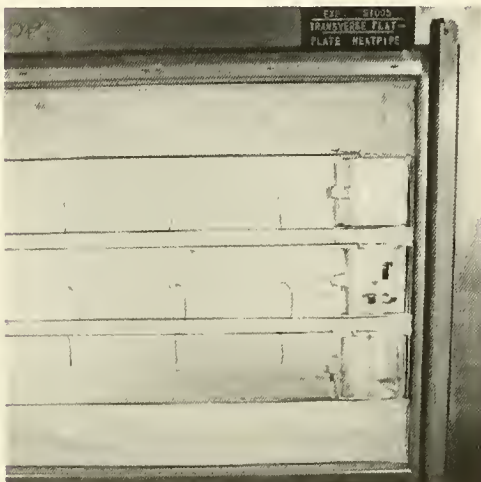
Figure 205 (Postflight). This photograph of the right of the tray shows that the silvered Teflon film now appears diffuse. Space debris impacts appear as small black dots. There is an area of brown discoloration on the right end of the center heat pipe module.

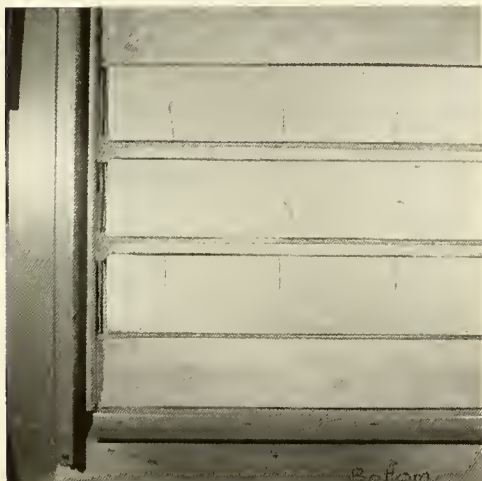
Figure 206 (Postflight). This photograph of the lower left of the tray shows that the silvered Teflon film now appears diffuse. Space debris impacts appear as small black dots.

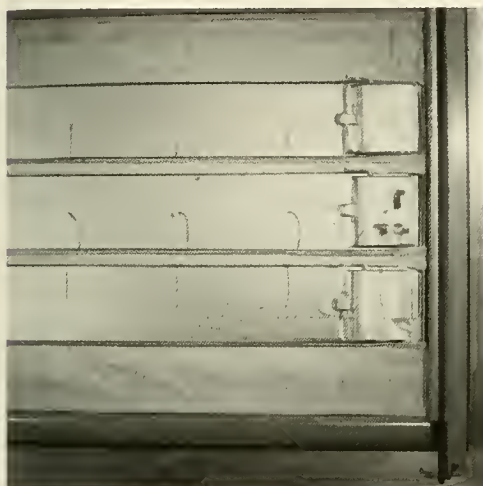
Figure 207 (Postflight). This photograph of the lower right of the tray shows that the silvered Teflon film now appears diffuse. Space debris impacts appear as small black dots. There is an area of brown discoloration on the right end of the center heat pipe module.

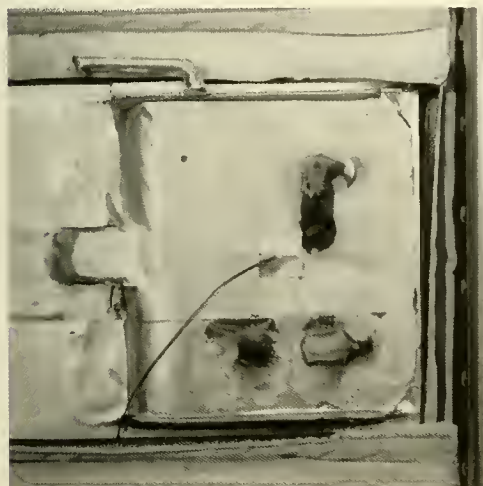
Figure 208 (Postflight). This close-up photograph is of the discolored area on the right end of the center heat pipe module.

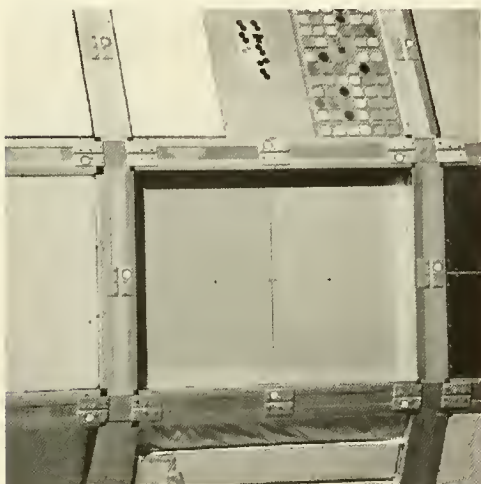
Figure 209 (In Flight). The discolorations on the lower left sidewall of the experiment tray appear to be fingerprints from prelaunch handling. A portion of the pink and greenish-gray tint on the two debris panels are by-products of the chromic anodize coating process; however, part of the intensity can be attributed to reflections of the blue sky. The vertical streaks on the right debris panel are by-products of chromic anodizing that have been enhanced by the blue reflection. A light irregular discoloration is visible on the left debris panel; it starts near the center of the left edge and progresses down and to the right. The light band along the vertical edge of the left debris panel is a reflection from the tray sidewall.

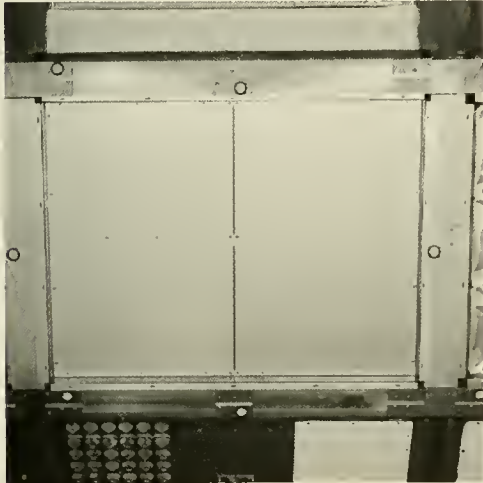
Figure 210 (Postflight). The postflight photograph was taken in the SAEF II at KSC prior to the removal of the experiment from the LDEF. The pink and greenish-gray tints on the two debris panels are by-products of the chromic anodize coating process and are not attributed to contamination or exposure to the space environment. The dark streaks observed on the right debris panel in the in-flight photograph are no longer visible because the reflection of the sky is not present. However, the light irregular discoloration starting near the center of the left edge is clearly visible on the left debris panel. The light band along the sides and across the bottom of the panels is caused by light reflecting from the tray sidewall.

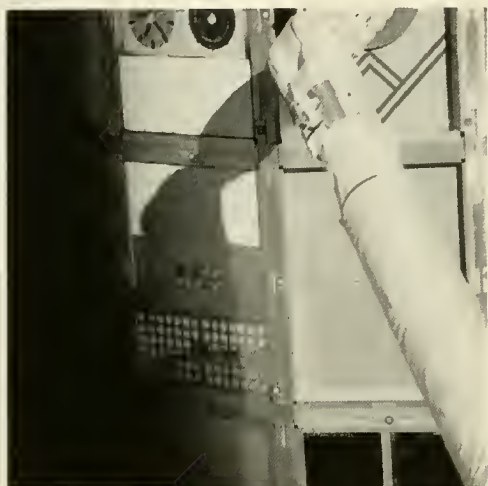
Figure 212 (In Flight). The in-flight photograph is covered by the shadow from the orbiter RMS arm and cannot be readily compared with the preflight photograph. The surface area that can be observed does not seem to be significantly degraded.

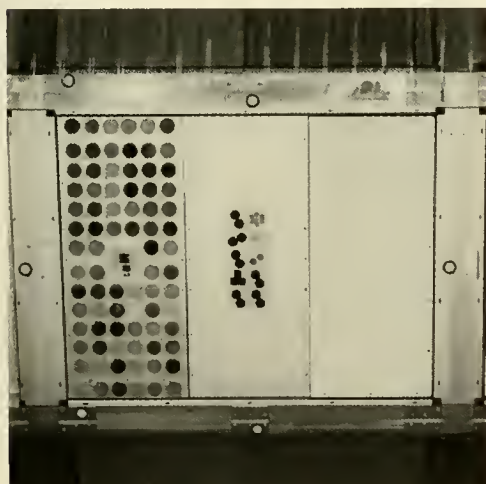
Figure 213 (Postflight). The postflight photograph shows little change to the exposed surfaces when compared with the preflight photograph. Although not noticeable in the photograph, a light coating of contamination was visible on all experiment surfaces in this location. The difference in the colors of the IDE detectors that are located on the left mounting plate is a result of the reflected surroundings and is not related to space exposure. The EPDS thermal cover on the right side of the tray shows a light coating of brown contamination on the Chemglaze II A-276 white paint. Markings along the top of the photograph are due to film processing.

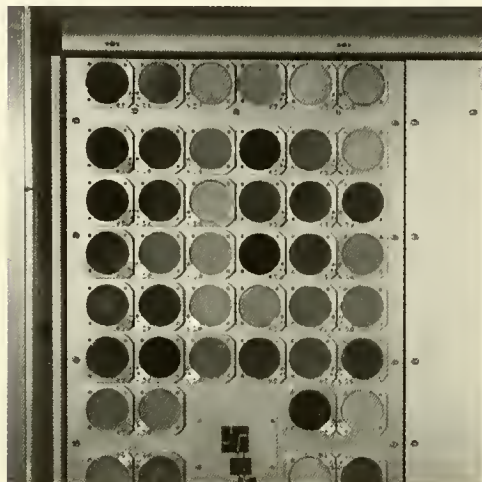
Figure 214 (Postflight). This photograph is of the upper left one-sixth of the tray. The difference in the colors of the IDE detectors is a result of the reflected surroundings and is not related to space exposure. The solar sensor located near the bottom of the photograph has changed little. The color of the solar array baseplate shows indications of contamination and appears to be darker than the detector mounting plate. A close observation of the detector surfaces reveals that some damage has occurred from meteoroid or debris impacts. One impact crater is visible on the detector located in the sixth row down from the top and the fifth row from the left. Other impacts, smaller in size, show as small white dots on the surface of the detectors.

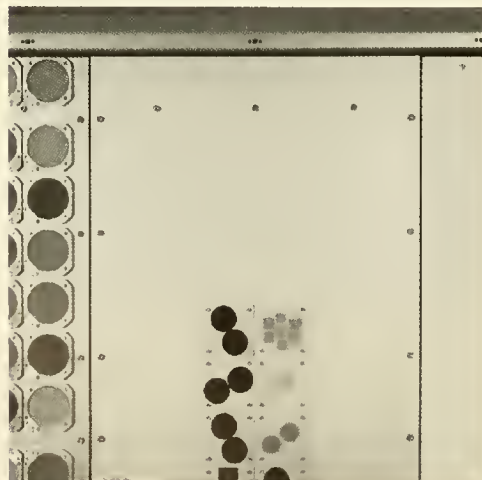
Figure 215 (Postflight). This photograph is of the upper center one-sixth of the tray. The center section cover plate shows little change except that a light coat of brown contamination can be observed on all surfaces. The color of the bonding material, which was used to secure several thin sapphire specimens to individual mounting plates at the bottom of the photograph, has changed from pink to gold. For one specimen, the bonding material is more gray than gold in color. This color difference has been attributed to the specimen being considerably thicker.

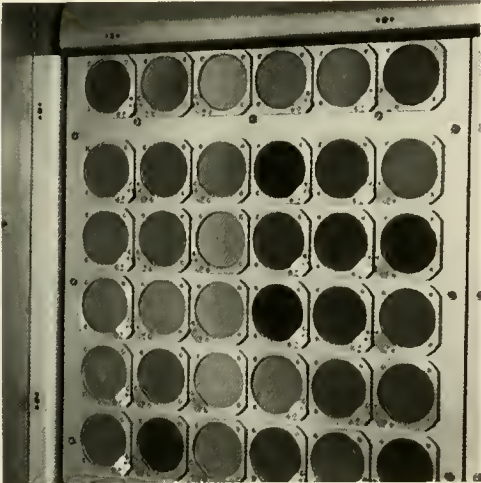
Figure 216 (Postflight). This close-up photograph is of the upper left one-sixth of the tray. The different colors of the impact detectors are caused by reflections of the surroundings. There are some space debris impact craters visible on some sensors. A large impact crater is visible on the sensor located second from the right in the bottom row. There also appear to be areas of discoloration or contamination around the edges of some sensors.

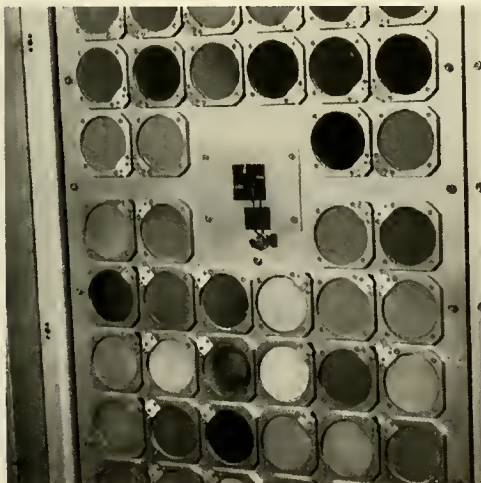
Figure 217 (Postflight). This photograph is of the center left one-third of the tray. Space debris impact craters are visible on some of the sensors. The different colors of the impact detectors are caused by reflections of the surroundings. Some reflections of room surroundings are visible in sensors in the left row. There also are areas of discoloration or contamination on or around the edges of some sensors. The solar sensor located near the bottom of the photograph has changed little. The color of the solar array baseplate shows indications of contamination and is a little darker than the detector mounting plate.

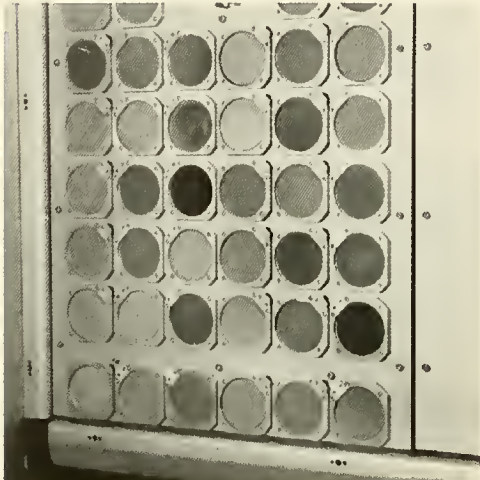
Figure 218 (Postflight). This photograph is of the lower left one-sixth of the tray. Space debris impact craters are visible on some of the sensors. There also appear to be areas of discoloration or contamination on or around the edges of some sensors. The different colors of the impact detectors are caused by reflections of the surroundings.

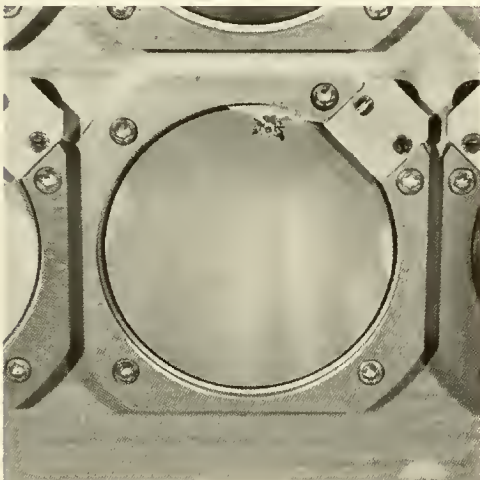
Figure 219 (Postflight). This close-up photograph is of a sensor and shows a space debris impact crater. This sensor is the second from the right in the second row from the bottom in the photograph shown in figure 218. Other small impacts are also visible.

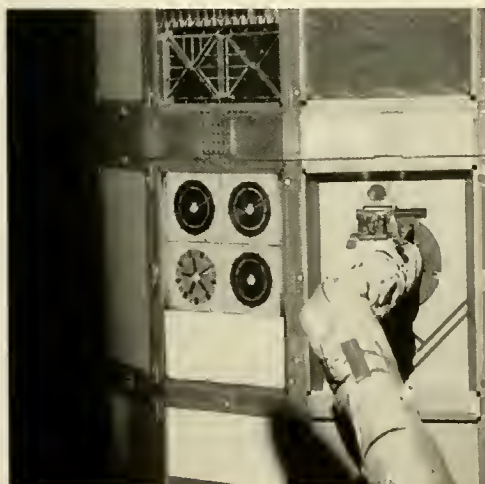
Figure 221 (In Flight). The grapple tray assembly appears to be without physical damage. The camera on the RMS end effector blocks out over half the target attached to the top edge of the grapple fixture. The RMS wrist joint and shadow partially block a view of the black chevrons. The chromic-anodized aluminum mounting plate and the upper and lower flanges of the tray are discolored by a light tan stain.

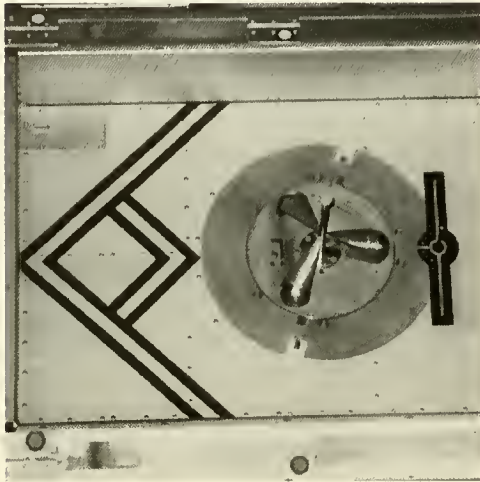
Figure 222 (Postflight). The grapple tray assembly appears to be without physical damage. The dark irregular discoloration on the lower right corner of the grapple fixture mounting plate is an abrasion that existed preflight. The pinkish tint on the mounting plate is a by-product of the chromic anodizing process and is not attributed to exposure to the space environment. The stripes on the black camera target and the tip of the vertical rod on the target have changed from white to brown. The light band along the right edge of the grapple fixture mounting plate is caused by light reflecting from the tray sidewalls.

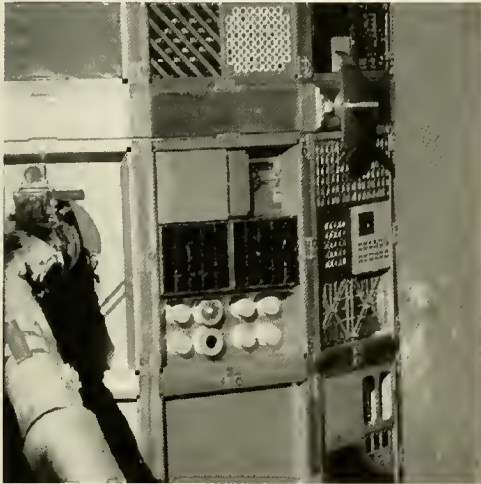
Figure 224 (In Flight). A brown stain is on the experiment hardware within the tray. Experiment AO015 has survived the extended mission with no visible damage. The Kapton covers are intact and all hardware is securely in place. Experiment AO187-2 capture cells have been severely degraded. Few, if any, of the 40 capture cell metallized Mylar covers survived the total mission. For many cells, pieces of the failed capture cover have curled into tight conical needles and are attached to the edges of the aluminum mounting frame.

The EECC containing experiment M0006 appears to be in excellent shape.

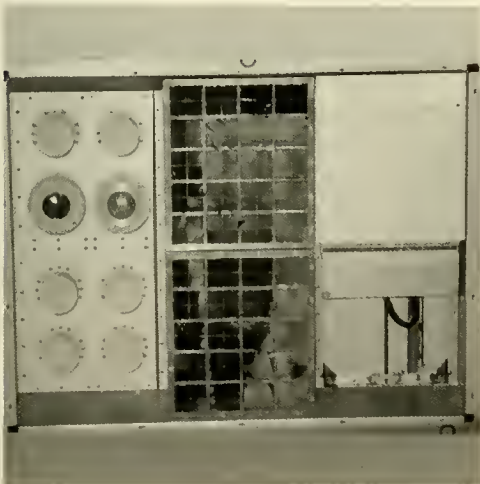
Figure 225 (Postflight). Most hardware is coated with a light brown or tan stain. Only one metallized Mylar cover for experiment AO187-2 survived the total mission. For other cells, pieces of the failed metallized Mylar cover curled into a tight conical shape and adhered to the edges of the aluminum mounting frame.

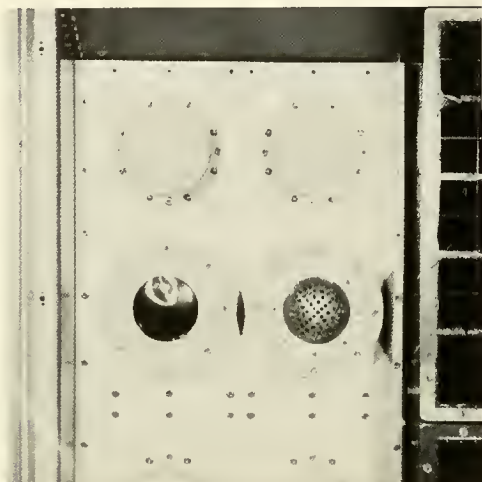
Figure 226 (Postflight). This photograph is of the upper left one-sixth of the tray. The bio-stack canisters have no damage, but there is a dimple in one orange Kapton cover dome. The canisters were white prior to flight, but are now a light tan.

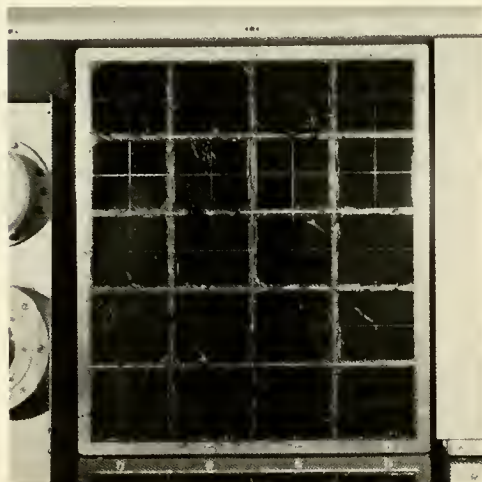
Figure 227 (Postflight). This photograph is of the upper center one-sixth of the tray. All the visible metallized Mylar capture cell covers have rolled up and are hanging loose. There are reflections of surrounding areas in the face of some capture cells.

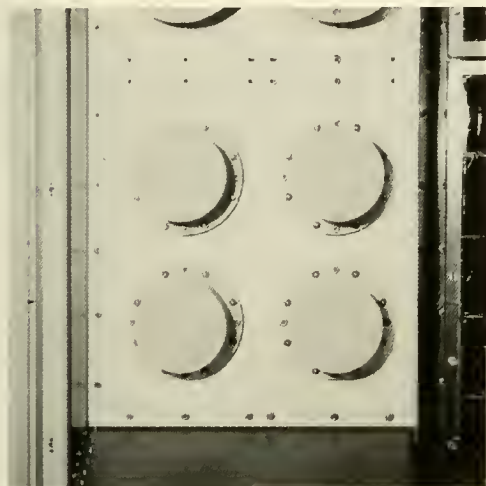
Figure 228 (Postflight). This photograph is of the lower left one-sixth of the tray. The canisters appear undamaged. The biostack canisters that were white prior to flight now have a light tan discoloration.

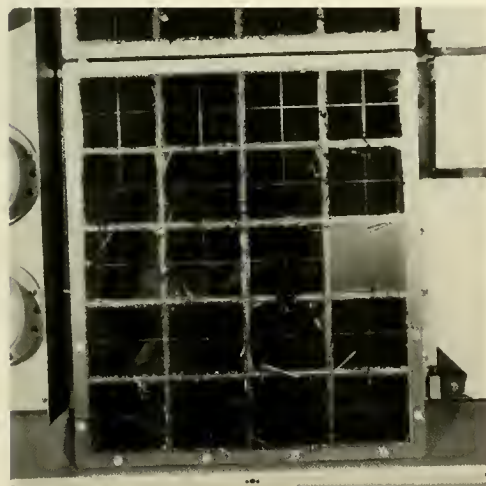
Figure 229 (Postflight). This photograph is of the lower center one-sixth of the tray. All but one of the metallized Mylar covers have rolled up and are hanging loose. There are reflections of surrounding areas in the face of some capture cells.

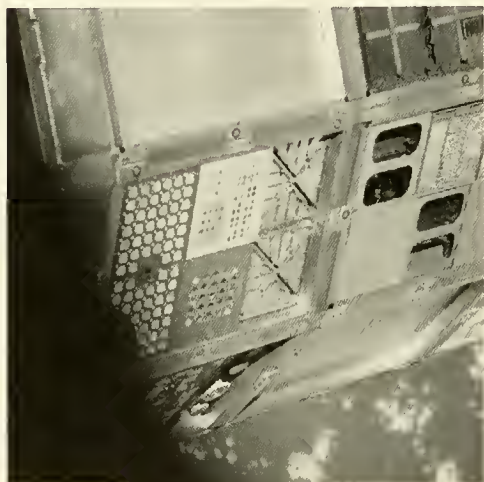
Figure 231 (In Flight). There is a brown stain on the tray structure and most aluminum surfaces of experiments within the tray. Experiment AO023 appears intact. The blue tint on the detector foils and also on the polished aluminum stop plates between the detector stacks is the reflection of the sky on the metallic surfaces.

The S13G-LO white paint on experiment AO114 has turned to a light tan with darker areas near the coverplate edges and above the polished aluminum cover plate. The blue tint on the polished aluminum cover plate and some of the specimen materials is attributed to a reflection of the sky.

The hardware of experiment AO201 that is not in shadow appears to have a thin brown film or stain on the exposed surfaces. The colors in the mirrorlike surface of the detectors are a reflection of the sky and the clouds.

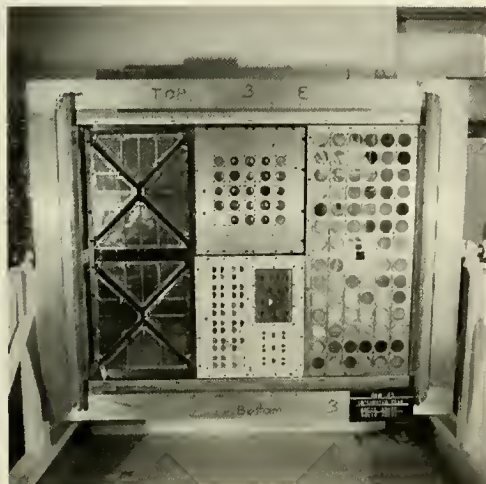
Figure 232
Photo No.: KSC-390C-1558.02
Dup. Neg. No.: L91-9090
LISAR No.: EL-1994-00213
Photo Credit: KSC
Photo Date: 3/5/90
Location: KSC SAEF II
Subject: Postflight Survey of Tray C3

Figure 232 (Postflight). Experiment surfaces have a brown stain that is consistent with other areas on the trailing side of the LDEF. Most noticeable is that the coverplate of experiment AO114, which was painted with white paint (S13G-LO), is now light tan.

Experiment AO023 has no visible damage. The die-cast frame, the mesh, the detector foils, and the bond joints are intact. Reflections from the photographic light sources are visible on the surfaces of specimens located in the cavities behind the cover plate.

The colors and designs on detectors of experiment AO201 are reflections of the surrounding area.

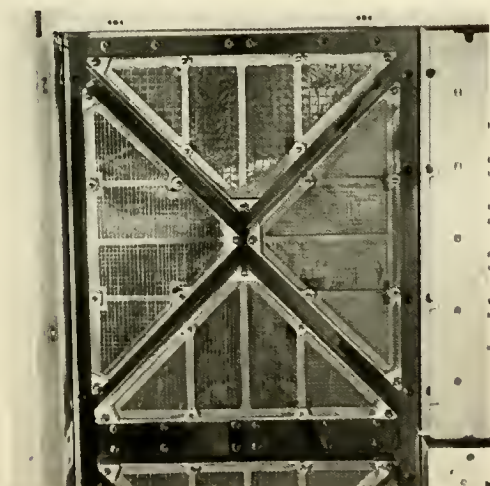
Figure 233
Photo No.: KSC-390C-1558.03
Dup. Neg. No.: L91-9091
LISAR No.: EL-1994-00339
Photo Credit: KSC
Photo Date: 3/5/90
Location: KSC SAEF II
Subject: Postflight Detail of Upper Left of Tray C3

Figure 233 (Postflight). This photograph is of the upper left one-sixth of the tray. The hardware of experiment AO023 appears intact, but some discoloration on the mounting hardware surfaces is apparent. Considerable staining is visible along the bond line between the support mesh and die-cast frame where the adhesive may not have been completely cleaned during pre-launch preparations. Reflections in the foil surfaces are visible.

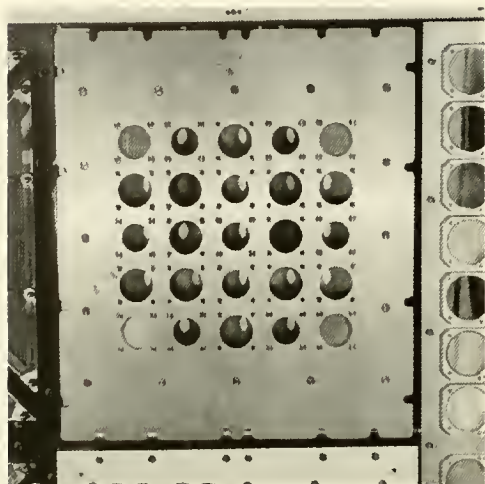
Figure 234
Photo No.: KSC-390C-1558.04
Dup. Neg. No.: L91-9092
LISAR No.: EL-1994-00340
Photo Credit: KSC
Photo Date: 3/5/90
Location: KSC SAEF II
Subject: Postflight Detail of Upper Center of
Tray C3

Figure 234 (Postflight). This photograph is of the upper center one-sixth of the tray. Experiment AO034 has some uniform brown discoloration on the cover plate surface. Reflections from photographic lights are visible on the sensor surfaces.

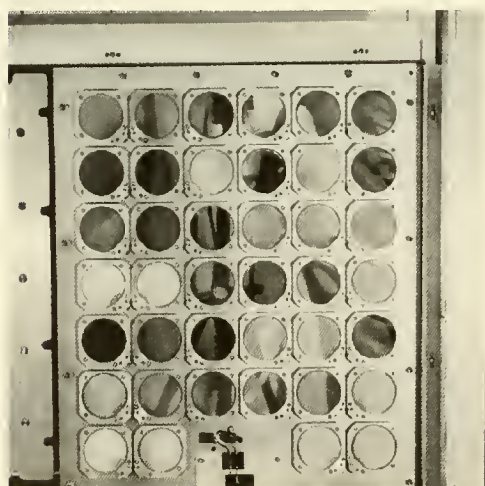
Figure 235
Photo No.: KSC-390C-1558.05
Dup. Neg. No.: L91-9093
LISAR No.: EL-1994-00351
Photo Credit: KSC
Photo Date: 3/5/90
Location: KSC SAEF II
Subject: Postflight Detail of Upper Right of Tray C3

Figure 235 (Postflight). This photograph is of the upper right one-sixth of the tray. The sensors of experiment AO201 are intact. There is a brown discoloration on the detector frames and baseplate. A reflection of the room surroundings is visible in the sensor surfaces.

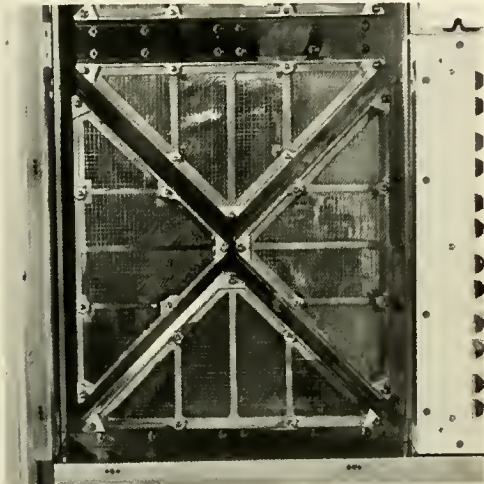
Figure 236
Photo No.: KSC-390C-1558.06
Dup. Neg. No.: L91-9094
LISAR No.: EL-1994-00352
Photo Credit: KSC
Photo Date: 3/5/90
Location: KSC SAEF II
Subject: Postflight Detail of Lower Left of Tray C3

Figure 236 (Postflight). This photograph is of the lower left one-sixth of the tray. The hardware of experiment AO023 is intact, but some discoloration on the mounting hardware surfaces is apparent. Considerable staining is visible along the bond line between the support mesh and the die-cast frame where the adhesive may not have been completely cleaned during prelaunch preparations. Reflections in the foil surfaces are visible.

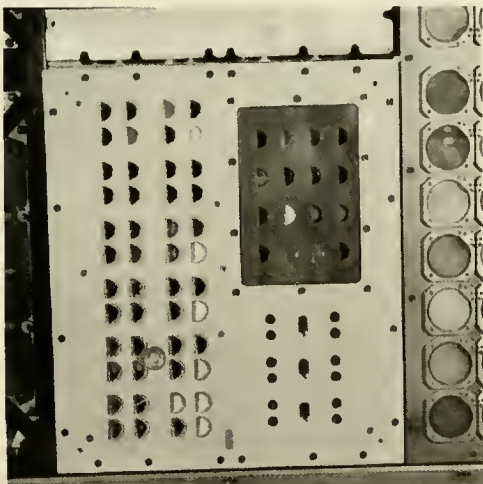
Figure 237
Photo No.: KSC-390C-1558.07
Dup. Neg. No.: L91-9095
LISAR No.: EL-1994-00364
Photo Credit: KSC
Photo Date: 3/5/90
Location: KSC SAEF II
Subject: Postflight Detail of Lower Center of
Tray C3

Figure 237 (Postflight). This photograph is of the lower center one-sixth of the tray. The sensors of experiment AO114 seem to be intact. The paint that was originally white on the faceplate is now a uniform light tan. The polished aluminum face plate insert in the upper right quadrant has become darker.

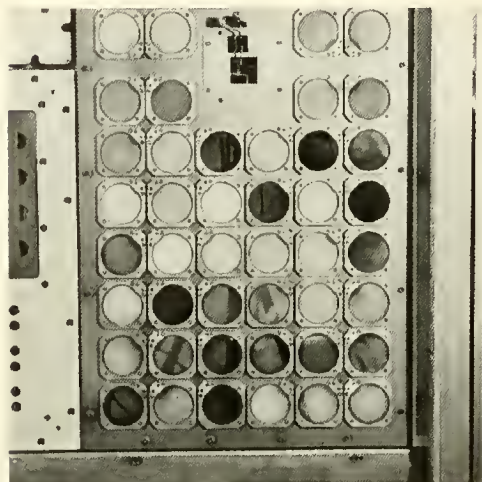
Figure 238 (Postflight). This photograph is of the lower right one-sixth of the tray. The sensors of experiment AO201 are intact. There is a brown discoloration on the detector frames and baseplate. A reflection of the nearby surroundings is visible in the sensor surfaces.

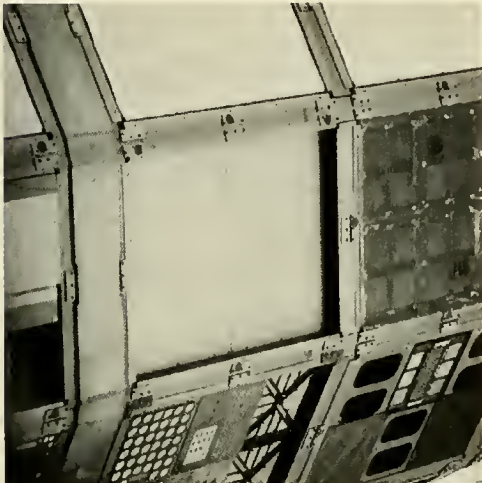
Figure 239 (In Flight). The greenish-gray tint on the debris panels is a by-product of the chromic anodize coating process. The dark green smudge along the top right edge of the left debris panel is the result of improper cleaning after prelaunch handling. The dark band across the bottom of the panels is caused by a shadow from the tray sidewall.

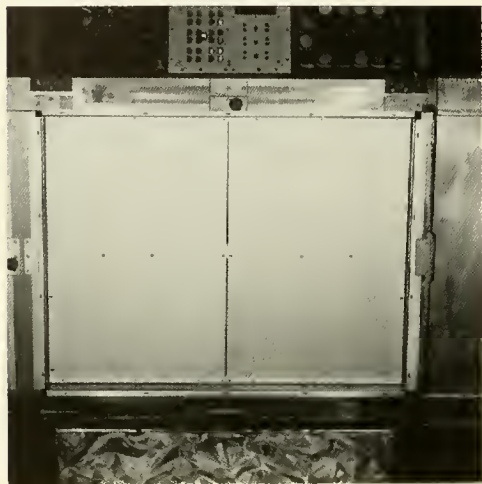
Figure 240
Photo No.: KSC-390C-832.05
Dup. Neg. No.: L90-13352
LISAR No.: EL-1994-00173
Photo Credit: KSC
Photo Date: 2/7/90
Location: KSC SAEF II
Subject: Postflight Survey of Tray C4

Figure 240 (Postflight). The greenish-gray and pink tints on the two debris panels are by-products of the chromic anodize coating process and are not attributed to contamination or exposure to the space environment. The smudges on the panels along the bottom center of the tray are the result of improper cleaning after panel installation. The light band along the sides and across the top of the panels is caused by light reflecting from the tray sidewalls.

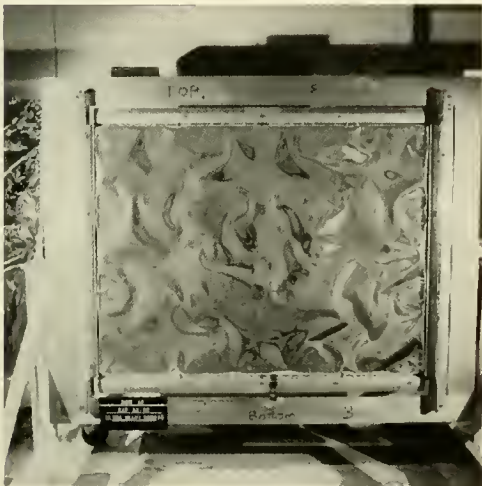
Figure 241 (Postflight). The thermal cover appears to be specular with no apparent damage. The cover is less taut than in the in-flight photograph and the locations of Velcro attachment pads are less prominent. The green on the right one-third of the thermal cover are reflections from the surroundings. The scallop effect around the cover edges occurs between the attachment pads and shows the upper edge of the support frame. The ground strap is in place with no visible damage; however, it is a deeper copper color than in the prelaunch photograph.

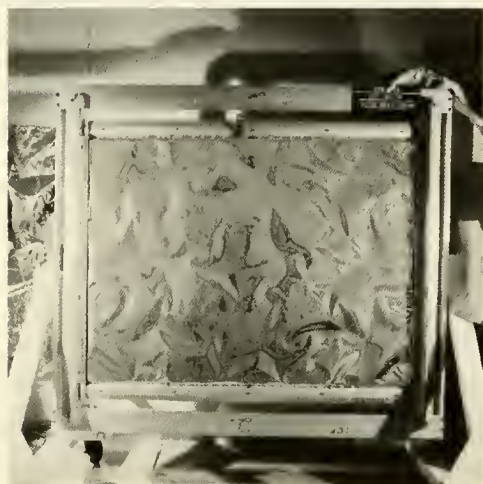
Figure 242 (Postflight). The thermal cover appears to be specular with no apparent damage. The green on the right one-third of the thermal cover are reflections from the surroundings. The ground strap is in place with no visible damage; however, it is a deeper copper color than in the prelaunch photograph.

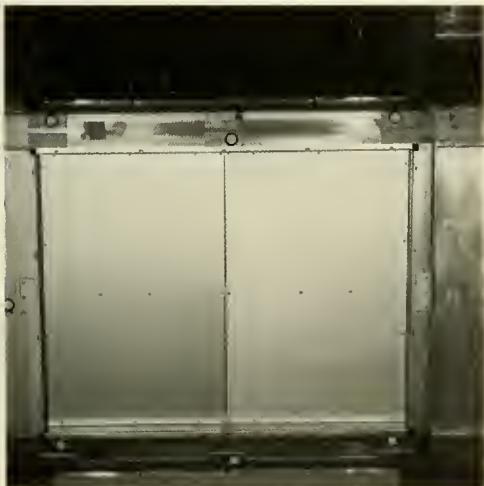
Figure 243 (Postflight). The pink and greenish-gray tints on the two debris panels are by-products of the chromic anodize coating process and are not attributed to contamination or exposure to the space environment. The two white spots in the lower left quadrant of the left debris panel appear to be debris impact craters. The light band along the right side and across the bottom of the panels is caused by light reflecting from the tray sidewalls.

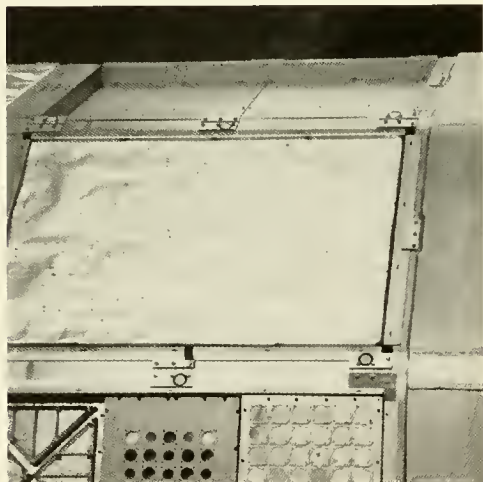
Figure 244 (In Flight). The ground strap located in the center of the lower flange is intact but with a much darker copper color than in the prelaunch photograph. The thermal cover surface appears to have changed from specular to opaque (glossy white) and to be marked with many black dots of various sizes that appear to be impacts or penetrations. Many discolorations have a black center encircled by a brown halo. The cover appears to be more taut than in the prelaunch photograph and the locations of Velcro attachment pads appear as oblong indentations in the thermal cover.

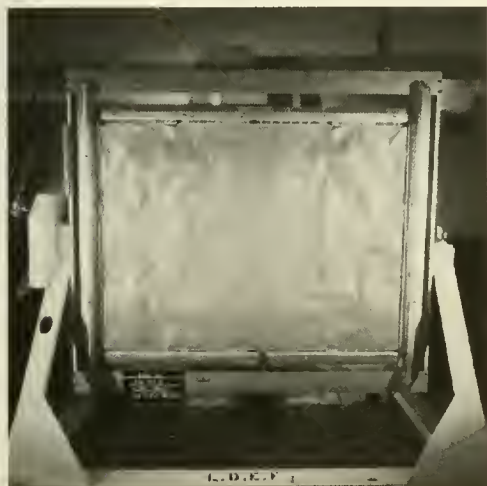
Figure 245
Photo No.: KSC-390C-1543.09
Dup. Neg. No.: L91-8886
LISAR No.: EL-1994-00212
Photo Credit: KSC
Photo Date: 3/2/90
Location: KSC SAEF II
Subject: Postflight Survey of Tray C8

Figure 245 (Postflight). The thermal cover surface appears to have changed from specular to opaque (glossy white) with many black dots of various sizes that appear to be impact or penetration discolorations. Many of the discolorations appear to have a black center encircled by a brown halo and then by a white halo. Other white circular discolorations also appear on the cover surface. The darker discolorations are probably the result of craters penetrating the 5-mil Teflon film, thus allowing atomic oxygen to oxidize or erode the layer of vapor-deposited silver beneath. An item of interest is the impact crater in the lower right corner of the cover that has a spray pattern originating from the point of impact. The cover is not as taut as in the in-flight photograph and the locations of Velcro attachment pads are not as prominent. The ground strap is in place with no visible damage; however, it is a deeper copper color.

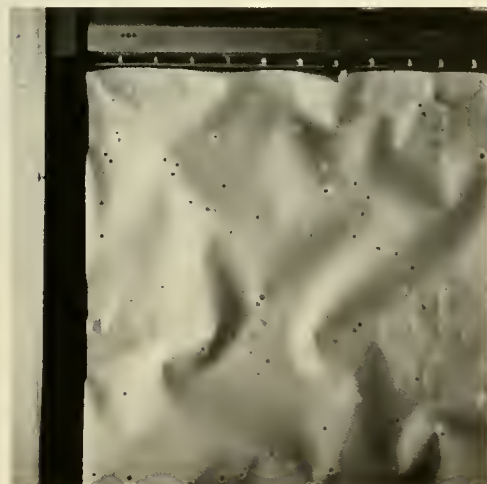
Figure 246
Photo No.: KSC-390C-1543.10
Dup. Neg.: L91-8887
LISAR No.: EL-1994-00154
Photo Credit: KSC
Photo Date: 3/2/90
Location: KSC SAEF II
Subject: Postflight Detail of Upper Left of Tray C8

Figure 246 (Postflight). This photograph is of the upper left one-sixth of the tray. The thermal cover appears opaque with numerous discolored impacts or penetrations. The thermal cover Velcro attachment pads are evident.

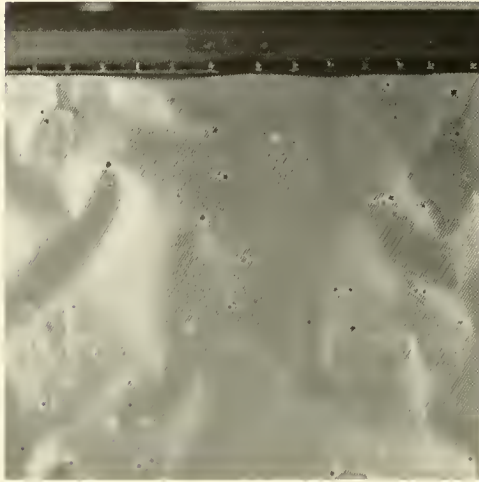
Figure 247 (Postflight). This photograph is of the upper center one-sixth of the tray. The thermal cover appears opaque with numerous discolored impacts or penetrations. The thermal cover Velcro attachment pads are evident.

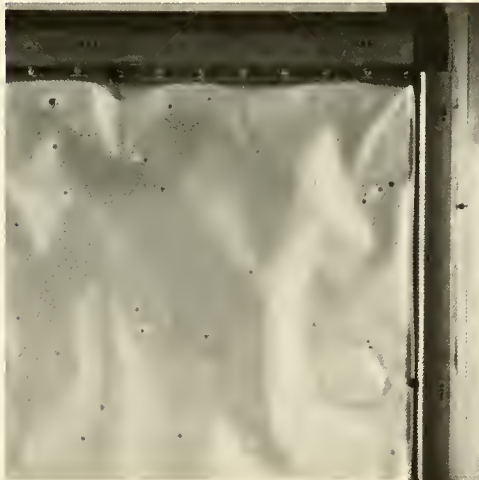
Figure 248 (Postflight). This photograph is of the upper right one-sixth of the tray. The thermal cover appears opaque with numerous discolored impacts or penetrations. The thermal cover Velcro attachment pads are evident.

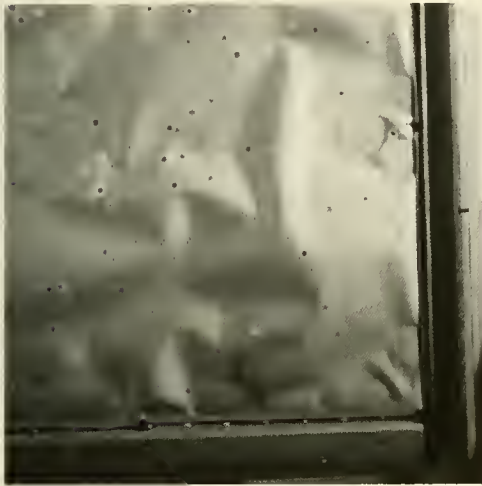
Figure 249 (Postflight). This photograph is of the lower right one-sixth of the tray. The thermal cover appears opaque with numerous discolored impacts or penetrations. The thermal cover Velcro attachment pads are evident.

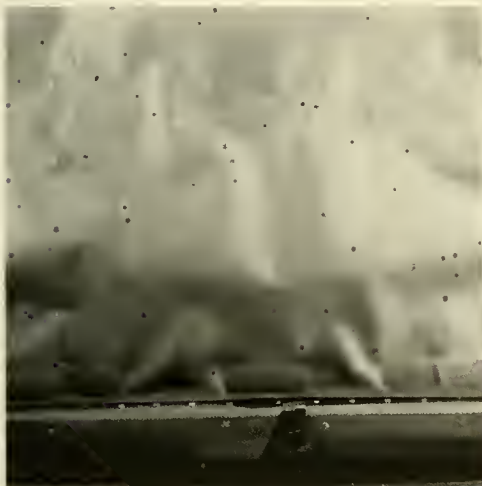
Figure 250 (Postflight). This photograph is of the lower center one-sixth of the tray. The thermal cover appears opaque with numerous discolored impacts or penetrations. The thermal cover Velcro attachment pads are evident.

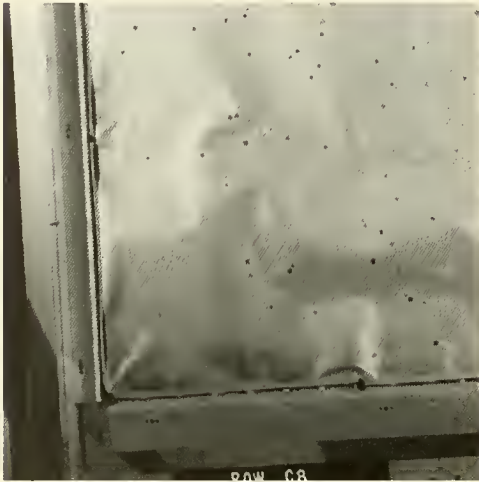
Figure 251 (Postflight). This photograph is of the lower left one-sixth of the tray. The thermal cover appears opaque with numerous discolored impacts or penetrations. The thermal cover Velcro attachment pads are evident.

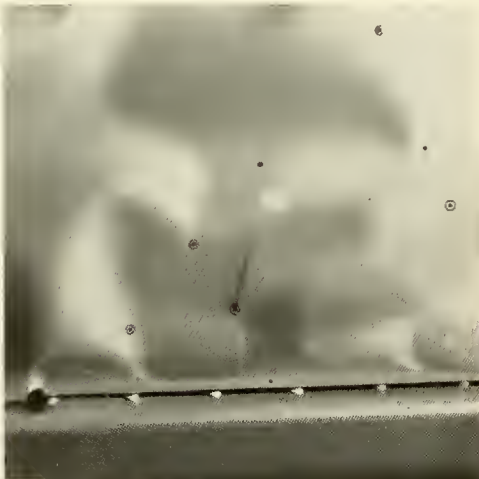
Figure 252 (Postflight). This close-up is of an impact or penetration in the lower right of the tray. A pronounced spray pattern extends away from the point of impact.

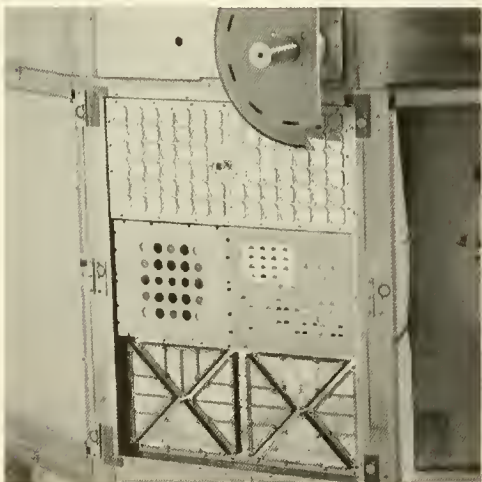
Figure 254 (In Flight). The tray appears to be unchanged from the preflight condition except for a little discoloration around some fasteners and on the mounting plates. Reflections of the surroundings appear to exist on some sensor surfaces. All experiment hardware appears intact. The color of the center coverplates was influenced by lighting conditions.

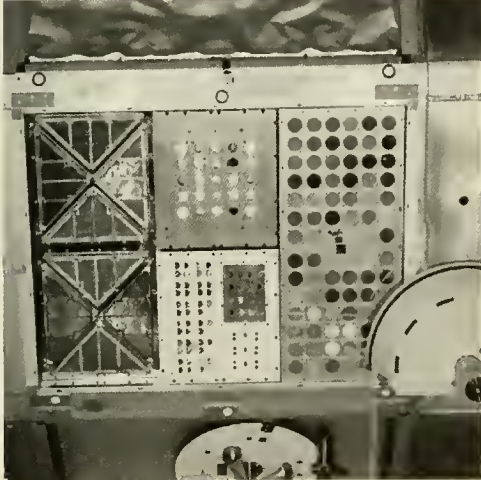
Figure 255
Photo No.: KSC-390C-1030.09
Dup. Neg. No.: L90-13407
LISAR No.: EL-1994-00143
Photo Credit: KSC
Photo Date: 2/9/90
Location: KSC SAEF II
Subject: Postflight Survey of Tray C9

Figure 255 (Postflight). The tray corner clamp blocks are unanodized aluminum, which accounts for the difference in color between the corner clamp blocks and the center clamp blocks. All experiments are intact. Reflections of the surroundings are visible in the sensor surfaces.

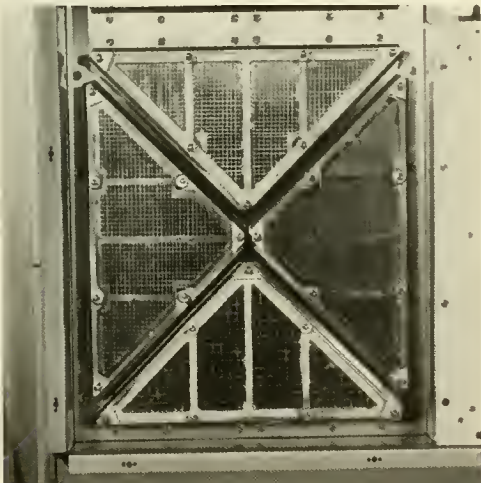
Figure 256
Photo No.: KSC-390C-1538.02
Dup. Neg. No.: L91-8840
LISAR No.: EL-1994-00692
Photo Credit: KSC
Photo Date: 3/2/90
Location: KSC SAEF II
Subject: Postflight Detail of Lower Left of Tray C9

Figure 256 (Postflight). This photograph is of the lower left one-sixth of the tray. The mesh support, the detector foils, and the bond joints show no sign of physical failure. There are some darker contamination stains in areas on the die-cast aluminum frames where adhesive residue remained after preflight cleaning.
